CASE

Apartment building construction quality varies widely throughout North America as developers manage a fine line between cost of construction and making a profit. Design plays an integral role in their longevity as well as climate of course. Denver, Colorado, where this case study of an older 45-apartment complex is focused, is a case in point where design plays a very significant role in how it faces the elements.

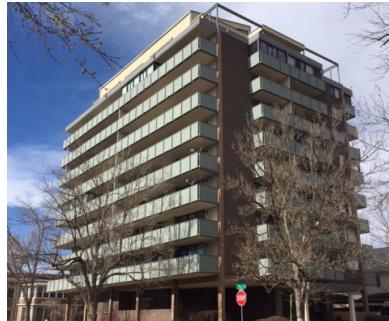
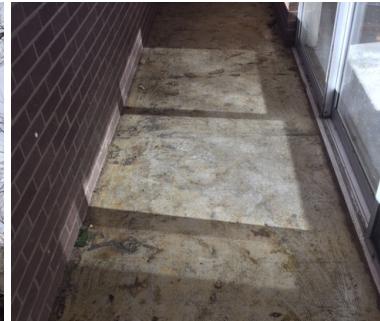
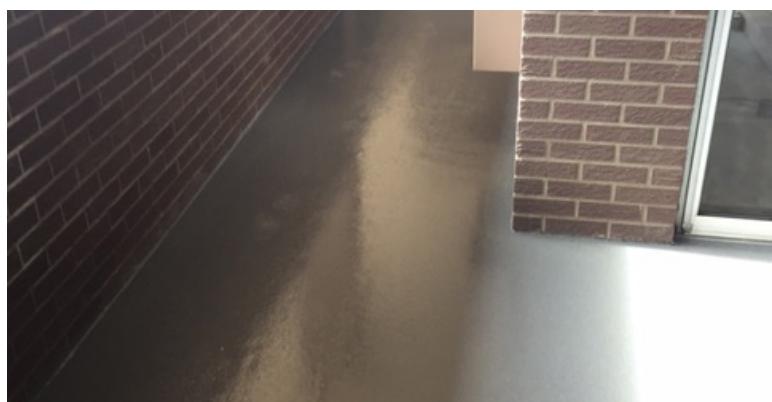
In this case, because there was a visual appeal aspect as well as a safety one,

1/16th inch flake chips were added. Not only did the chips give texture appeal, they also provided a rough surface for residents to walk on.

Ecodur, because of having no VOC's, did not require any special measures for the residents as only the applicators had to wear standard safety gear when they applied a 30-mil coating. The coating is virtually odorless, with some people reporting a pleasant, faint smell of castor oil. Within 30 minutes the coating 'kicks in' and is fully cured within 24 hours at which point a final inspection was done and the balconies released back to the residents for their use.

With one of the most vulnerable areas of the building's envelope sealed in this way, further damage to the concrete has been arrested completely. Should any physical damage occur in the future from heavy object impact, the previously stated indefinite ability of repair coatings to bond to old but dry and clean Ecodur surfaces, will be an important in long-term preservation strategies.
