CASE

Production facilities handling the beans need robust coatings. In this case, involving a plant at the largest cooperative soybean processing company in the world, the client wanted a 'green' product.

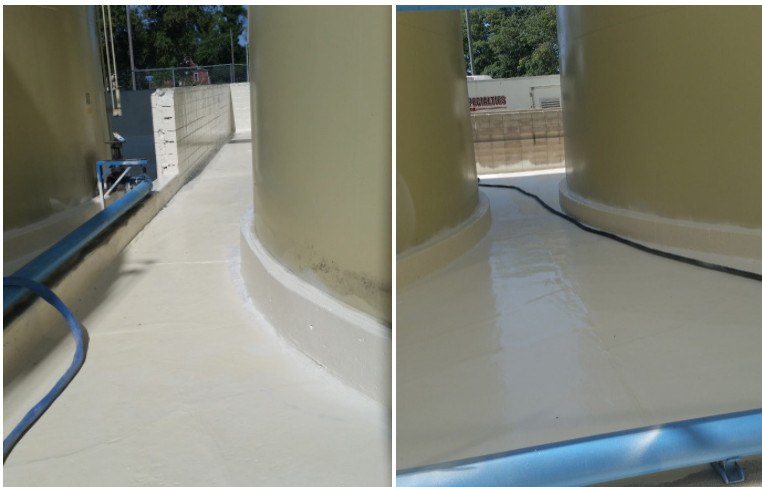
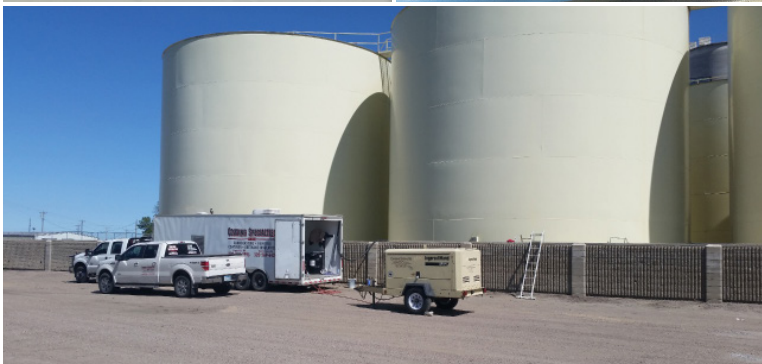
The applicator, Coating Specialties, sprayed a 40 mls coat on the concrete containment area for the tanks. With no practical limitations on thickness, this also allowed for crevices to be filled.

The coating was touch dry in about 30 minutes which is the normal setting time, and the entire cure was also achieved in a standard period of 24 hours at which time it was given a final inspection and signed off ready for production throughput to resume.
