# CASE

The Mile High Stadium, officially called Sports Authority Field at Mile High, in Denver, Colorado, has a capacity of over 76,000 for NFL games and is the home of the Denver Broncos. It was opened in 2001, replacing the original stadium that was built in 1948 at a different location. It has sold out every home game since then.

## Problem

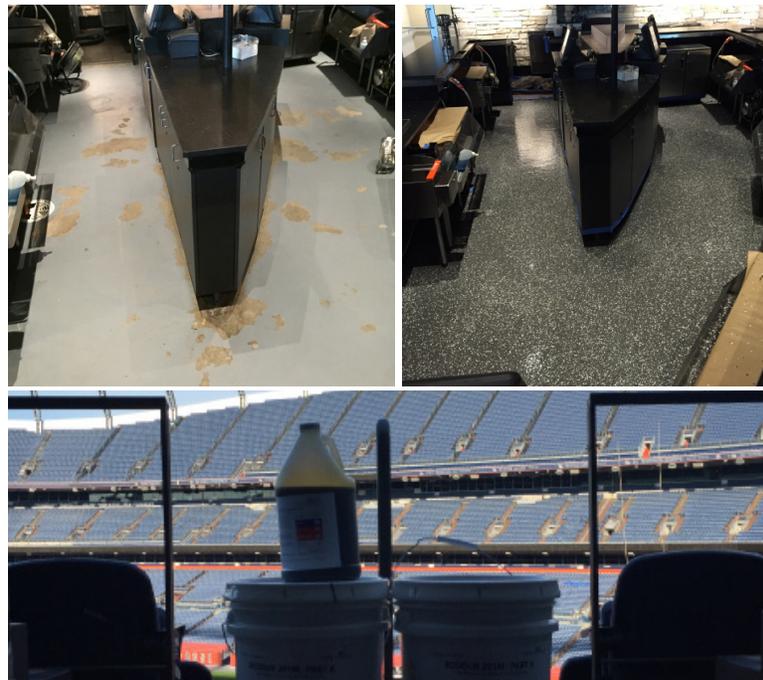
A major surface preparation had to be done prior to coating which included degreasing of food and beverage waste. The old, failing coating had to be completely removed and the surfaces left dry and absolutely clean. The restricted window for completion required fine planning and execution. The stadium has events all the time. Not completing the job on time was not an option as the VIP Club level brings in \$100,000s per day in sales.

The job used the manually applied version of Ecodur 201. The coating is very easy to mix prior to application, and, in the case of manually application, it only requires modest skill levels and only standard safety protection for protecting eyes and exposed skin, including breathing with a mask. Being free of Volatile Organic Compounds and quick set up, disruption was kept to an absolute minimum and the coating job was completed within the 2.5-day window. The coating cured within 24 hours and final inspection at that point allowed for an immediate handover.
